In the event of complaints about automatic resetting of turnsignal arm, check installation of combination switch on jacket tube and resetting cam on steering shaft prior to installing a new switch.

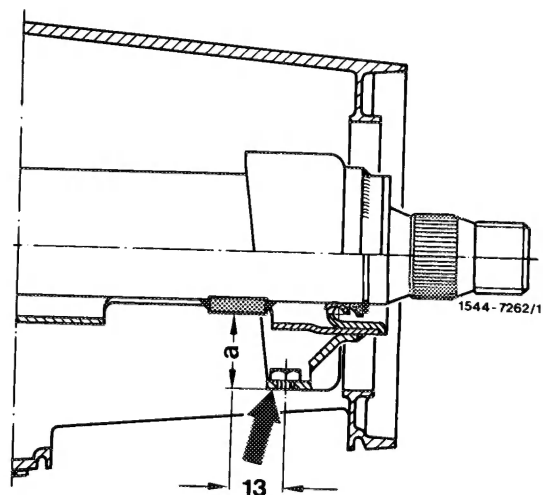
7 If traces of wear are showing up on resetting tongue of combination switch, check radii of resetting cam on steering shaft. If the resetting cam is sharp-edged on resetting surfaces, the resetting tongue of combination switch will be worn out.

8 Refinish sharp-edged resetting cam e.g. with a conventional grinding point (diameter approx. 6 mm) until a radius of approx. 0.8 mm is attained (arrows).
